PYNE GOULD CORPORATION BUILDING

INACHUS FP7 Project, Task 3.2, Italy, 2016

Forensic analysis of the Pyne Gould Building, Christchurch, New Zealand

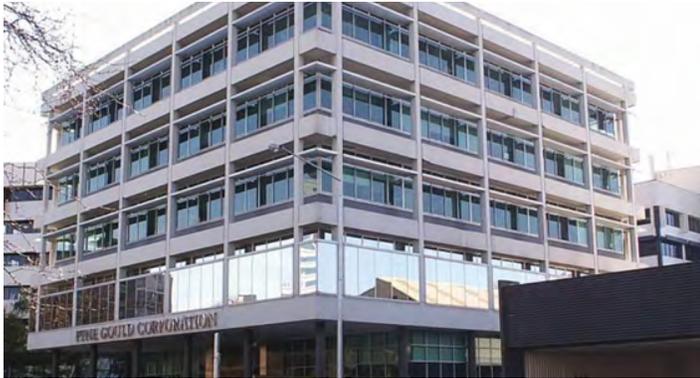
The Pyne Gould Corporation (PGC) Building at 231-233 Cambridge Terrace, Christchurch, New Zealand collapsed during the Magnitude 6.3 earthquake on Tuesday, February 22nd, 2011. The building was designed in 1963 as a reinforced concrete frame with an internal shear core. The structure had undergone two previous earthquakes, however no significant structural damage was observed after the earthquakes on September 4th, 2010 or the magnitude 4.9 earthquake on December 26th, 2010. During the earthquake on February 22nd, the building suffered a catastrophic progressive collapse, in which 18 people lost their lives.

Pyne Gould Building photographed from the South-East elevation after the 4 September 2011 earthquake

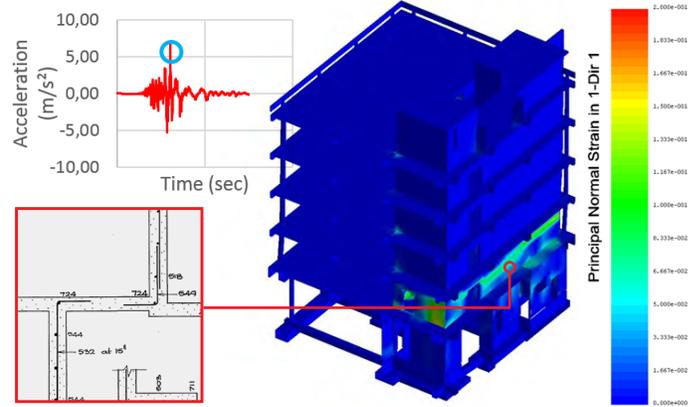
The analysis highlighted that the collapse occurred due to compressive buckling failure in the shear core. The failure can be attributed to the presence of a discontinuity in the shear core.

ELS plot of the Principal Normal Strain in Direction-1 immediately after the earthquake peak

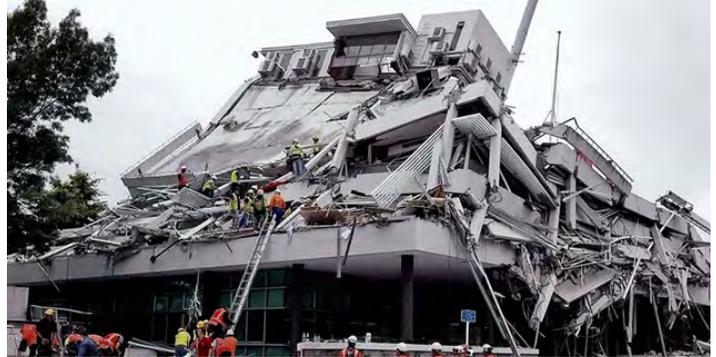
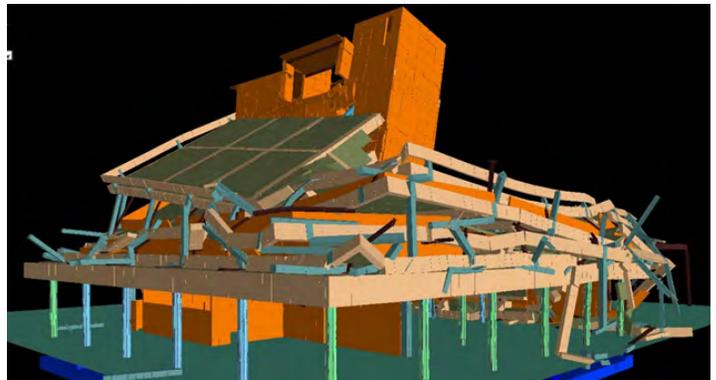
The final shape of the PGC building at the end of the ELS analysis shows a good correlation with the actual shape of the collapsed building documented by photographs after the earthquake.

ELS Results compared to a picture of the PGC building after the collapse
