St. Francis Central Hospital Pittsburgh, USA, 2008

In an impressive 10-second implosion, Saint Francis Central Hospital was erased from the Pittsburgh skyline on March 22, 2008. ASI was part of this story with its expertise and its advanced technology. However, there was a different story before this successful story.

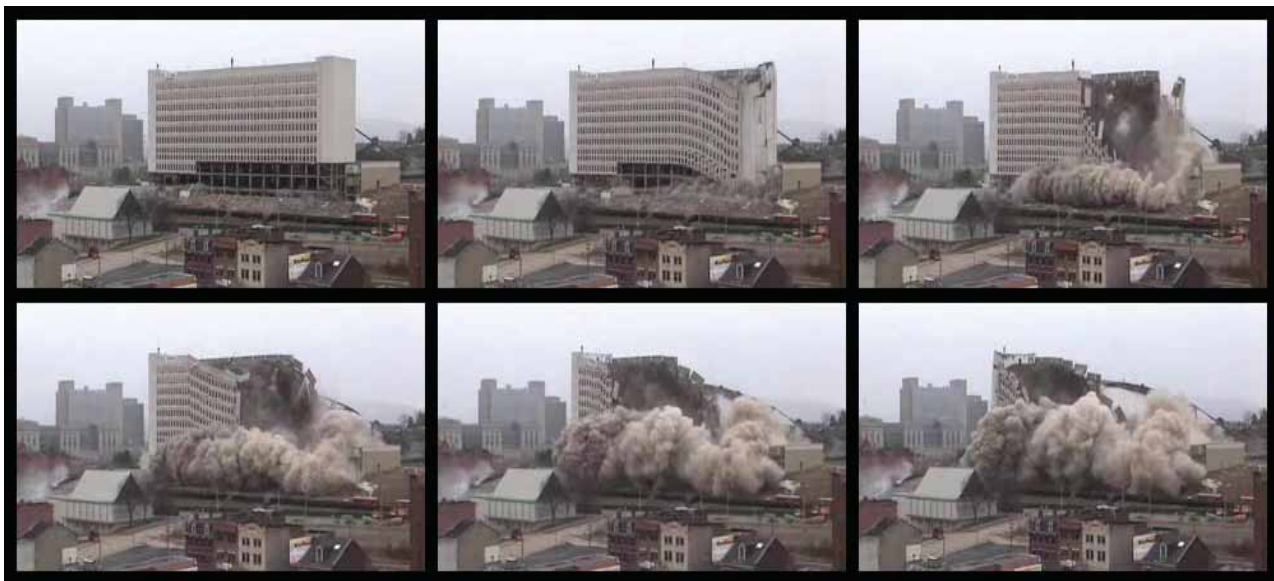
ASI constructed a full model of the structure using its trade-mark software Extreme loading for Structures (ELS). The model included all the details based on the original structural drawings and based on the changes that were made during the first attempt of demolition using controlled collapse. The ASI simulation showed that the components of the main structural system including vertical members, girders and reinforced concrete slabs are not affected by wind loading and no damage was observed in the pre-cast panels.

ASI estimated that there is a low potential of failure for the building under the effect of high winds. ASI also estimated that is safe for demolition workers to enter the building to do the work necessary to implode the building using explosives.

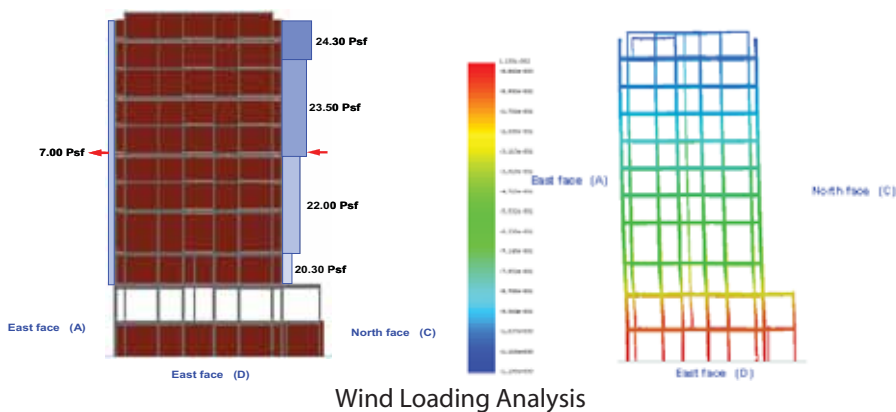
ASI also performed a simulation of the new demolition scenario proposed by Dykon Explosive Demolition Corporation. This simulation which was created before the demolition assured the contractor, the local authorities, the owners and occupants of neighboring buildings that this time the demolition will go as planned.

The actual implosion went almost exactly as the simulation. The only damage to one of the neighboring structures was the shattering of one of its windows. This type of damage might have been predicted by ELS. However, in this particular scenario glass analysis was not within the scope of work handed to ASI.
