APPLIED SCIENCE INTERNATIONAL SUCCESS STORY

NITERÓI HOSPITAL DEMOLITION

Santa Monica, Brazil, 2012

Assuring City Managers, Engineers, and Neighbors Using Engineered Analysis

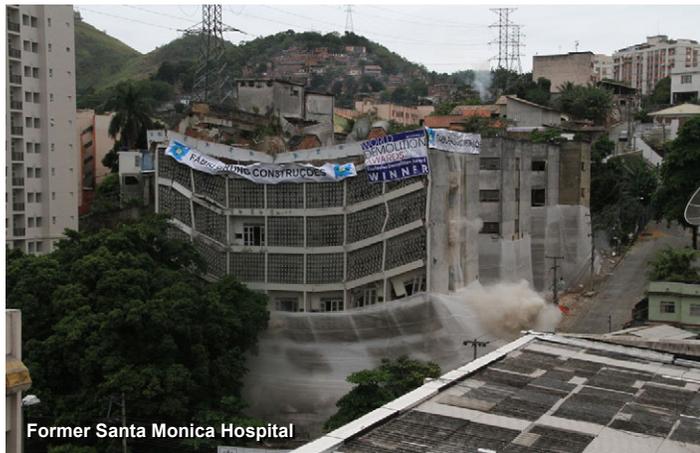
The close proximity of adjacent buildings and homes, large power cables, and the busiest street in Niterói a mere 30 feet down a slope from the former hospital raised considerable concerns prior to the implosion.

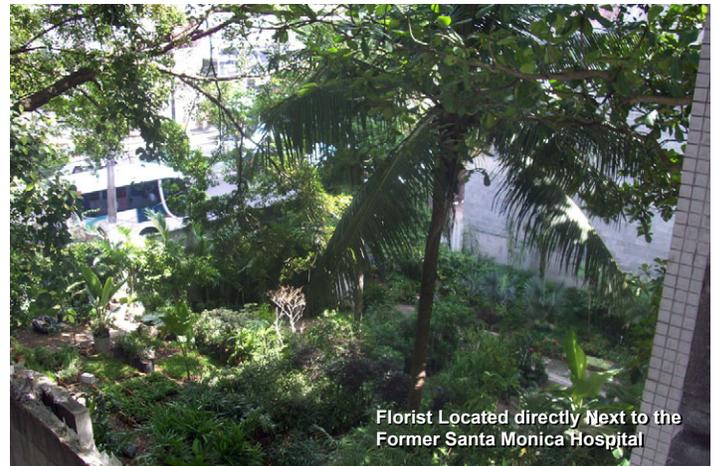
The implosion occurred without incident at 8:00 am, exactly on time. No power cables were damaged, no cracks were observed in any of the adjacent buildings, and all the debris was contained inside the building footprint as predicted. The peak particle velocity recorded by seismographs was below 3 mm/s, which was safely below the maximum limit of 15 mm/s allowed for by Brazilian standards.

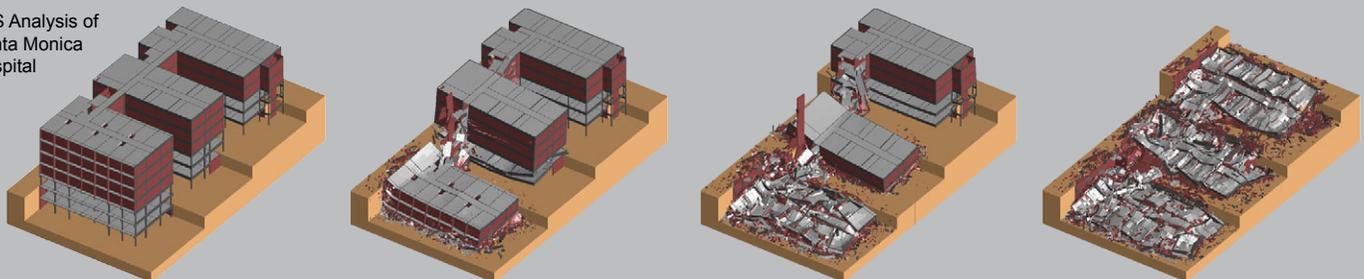
ELS Analysis of Santa Monica Hospital

Applied Science International (ASI) assisted in designing the implosion sequence. The primary goal of the design was to ensure that debris from the implosion fell toward the center of the buildings footprint, rather than along its edges. To achieve this, several scenarios were studied to decide which columns were to be loaded with explosives and which should be left uncharged, as well as the exact delay and sequence of the column removal.
