Titan Tire Company tasked ASI to perform vulnerability assessment for a facility in an existing building to test large mining tires. The gauge pressure of the tire ranges from 100 to 160 psi. The tire dimensions are up to 163" diameter and 70" wide.

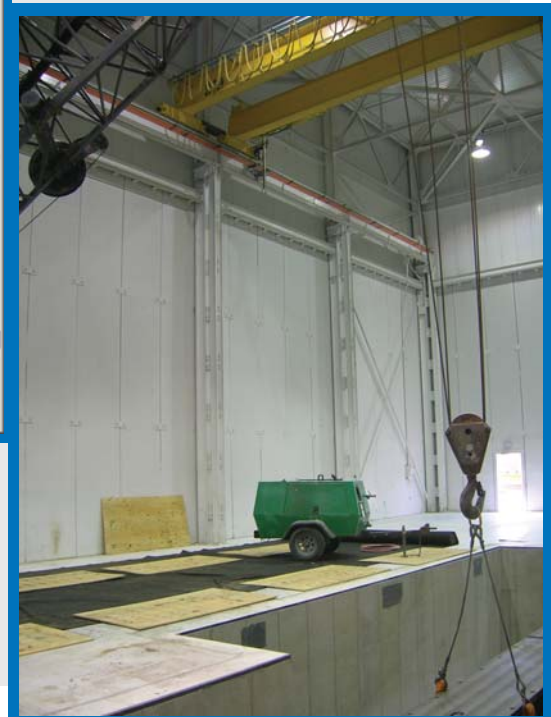
The existing building is a crane bay that consists of steel roof truss supported on steel columns, vertical and horizontal bracing, pre-cast panels, Concrete Masonry Units (CMU) walls, and covering steel sheets.

Actual Structural

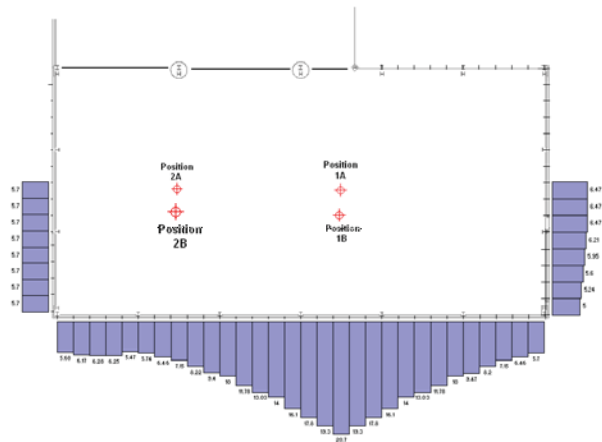
Pressure Distribution

ASI investigated the position of tire explosion which can occur and determined that the most critical failure would be 7 ft high above the ground level. At this critical height, ASI identified several critical scenarios for the location of the tire explosion and identified the dynamic loading due to the tire explosion on different components of the structure.
