During the erection of a deethanizer column at Yanbu Gas Plant Expansion Project, a mismatch between the anchor bolts and the skirt upper base plate holes was observed. In order to complete the erection process, the column vendor widened and slotted nine holes in the skirt base plate and totally removed three anchor bolts. Additionally, several anchor bolts were damaged and several others were subjected to excessive heat during flame cutting. This raised concern about the safety of the newly developed structure.

Saudi ARAMCO tasked Applied Science International (ASI) to use its in-house structural analysis software Extreme Loading® for Structures (ELS) to provide comparative structural modeling and analysis of the deethanizer column skirt. The objective is to compare the “as-designed” case with the actual damaged cases under the effect of wind and seismic loading conditions provided by Saudi ARAMCO.

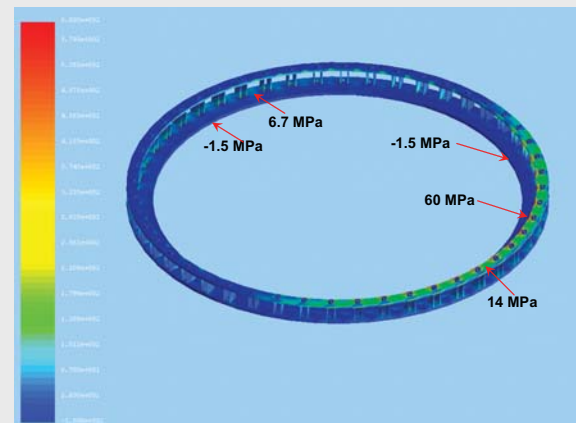
Principal stresses in the skirt base plate
